Project Name: EXAMPLE, PROPERTY NAME AND ADDRESS
Project Description: Condition and Connectivity
Project Date: 18/07/2019
Project Standard: MSCC5 Sewers & Drainage GB (SRM5 Scoring)

The survey was carried out to ascertain condition and connectivity.

The surveyed pipework consists of 100mm Vitrified Clayware.

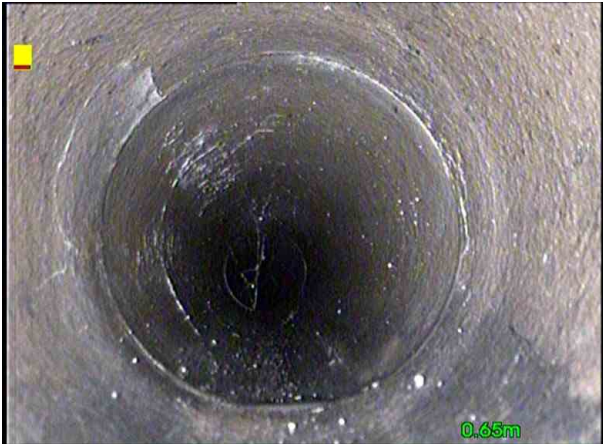
<table><tr> <td style="text-align: right;">0.00</td> <td>WL</td> <td>Water level, 5% of the vertical dimension</td> <td></td> <td></td> <td></td> <td></td> </tr><tr> <td style="text-align: right;">0.65</td> <td>CC</td> <td>Crack, circumferential from 12 o'clock to 12 o'clock</td> <td></td> <td>00:00:16</td> <td>MH1X_02 ace76e-24 f9-408b-a6</td> <td>2 / 2</td> </tr></table>

MH1X_02ace76e-24f9-408b-a62d-7bff35a29c37_20190719_090353_612.jpg, 00:00:16, 0.65 m
 Crack, circumferential from 12 o'clock to 12 o'clock

The defects observed can be repaired with the installation of part length and full-length structural liners, the liners are watertight, seamless and joint less and therefore cease any egress and ingress of water etc., and improve flow characteristics, the liners are structural and therefore return structural integrity to subject pipework. The installation of full-length structural liners greatly reduces disruption to site and cost of repair.

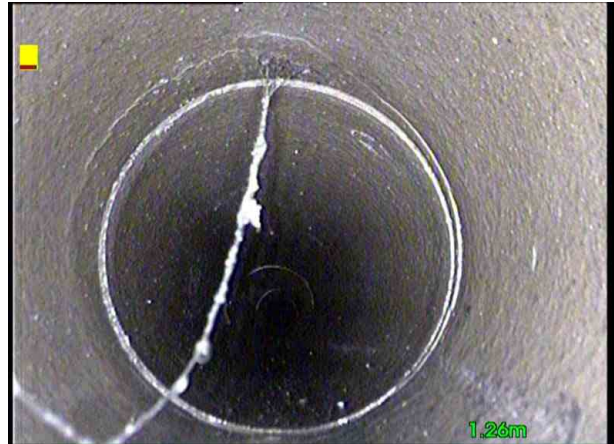
<table><tr> <td style="text-align: right;">0.00</td> <td>WL</td> <td>Water level, 5% of the vertical dimension</td> <td></td> <td></td> <td></td> <td></td> </tr><tr> <td style="text-align: right;">1.35</td> <td>CC</td> <td>Crack, circumferential from 12 o'clock to 12 o'clock</td> <td></td> <td>00:00:21</td> <td>MH1X_afb a63a8-869 4-4465-97</td> <td>2 / 2</td> </tr></table>

MH1X_afba63a8-8694-4465-9743-b969a1dd4529_20190719_090416_272.jpg, 00:00:21, 1.35 m
 Crack, circumferential from 12 o'clock to 12 o'clock

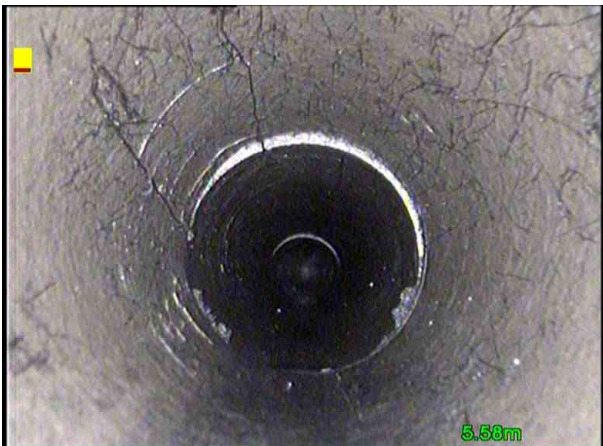
<table><tr> <td style="text-align: right;">0.00</td> <td>WL</td> <td>Water level, 5% of the vertical dimension</td> <td></td> <td></td> <td></td> <td></td> </tr><tr> <td style="text-align: right;">5.58</td> <td>S01</td> <td>RF</td> <td>Roots, fine, start</td> <td>00:00:49</td> <td>MH1X_2a 3f063b-ce 7e-4211-8</td> <td></td> </tr></table>

MH1X_2a3f063b-ce7e-4211-8c1e-818aead97839_20190719_090618_887.jpg, 00:00:49, 5.58 m
 Roots, fine, start

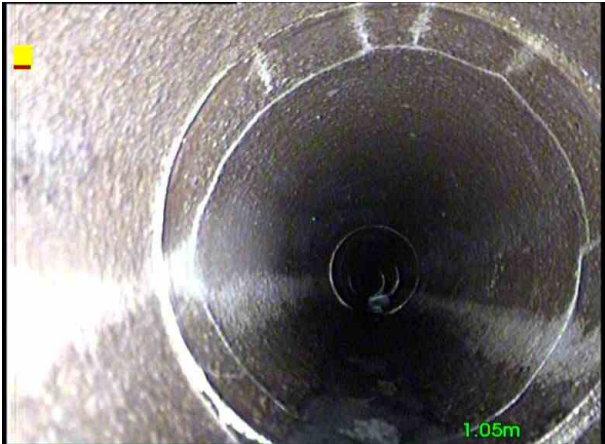
<table><tr> <td style="text-align: right;">0.00</td> <td>WL</td> <td>Water level, 5% of the vertical dimension</td> <td></td> <td></td> <td></td> <td></td> </tr><tr> <td style="text-align: right;">1.05</td> <td>CM</td> <td>Cracks, multiple from 12 o'clock to 12 o'clock</td> <td></td> <td>00:00:13</td> <td>MH2X_d1f 88f49-95b 6-4301-a0</td> <td>3 / 2</td> </tr></table>

MH2X_d1f88f49-95b6-4301-a031-a1a0e0d241b7_20190719_090934_524.jpg, 00:00:13, 1.05 m
 Cracks, multiple from 12 o'clock to 12 o'clock

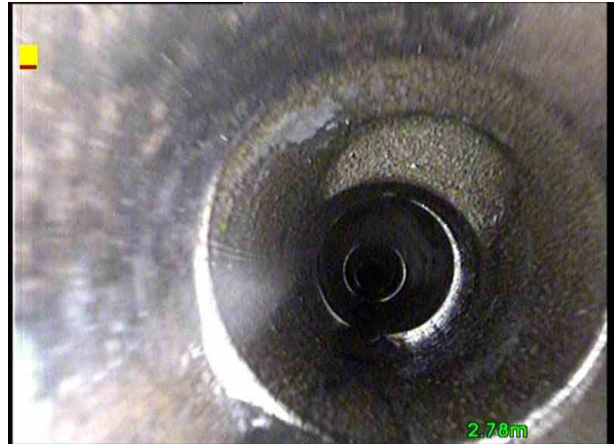
<table><tr> <td style="text-align: right;">0.00</td> <td>WL</td> <td>Water level, 5% of the vertical dimension</td> <td></td> <td></td> <td></td> <td></td> </tr><tr> <td style="text-align: right;">2.78</td> <td>JDM</td> <td>Joint displaced, medium</td> <td></td> <td>00:00:22</td> <td>MH2X_9e 4c6c1b-8d 0a-40b1-b</td> <td>1 / 3</td> </tr></table>

MH2X_9e4c6c1b-8d0a-40b1-b85c-89186ece19ae_20190719_091020_444.jpg, 00:00:22, 2.78 m
 Joint displaced, medium

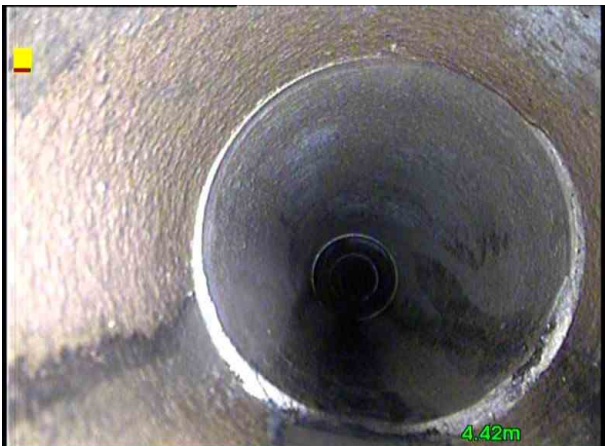
<table><tr> <td style="text-align: right;">0.00</td> <td>WL</td> <td>Water level, 5% of the vertical dimension</td> <td></td> <td></td> <td></td> <td></td> </tr><tr> <td style="text-align: right;">4.35</td> <td>JDM</td> <td>Joint displaced, medium</td> <td></td> <td>00:00:29</td> <td>MH2X_2c8 affc0-4bb9 -47ff-85b6-</td> <td>1 / 3</td> </tr></table>

MH2X_2c8affc0-4bb9-47ff-85b6-6fd752258e0d_20190719_091138_243.jpg, 00:00:29, 4.35 m
 Joint displaced, medium

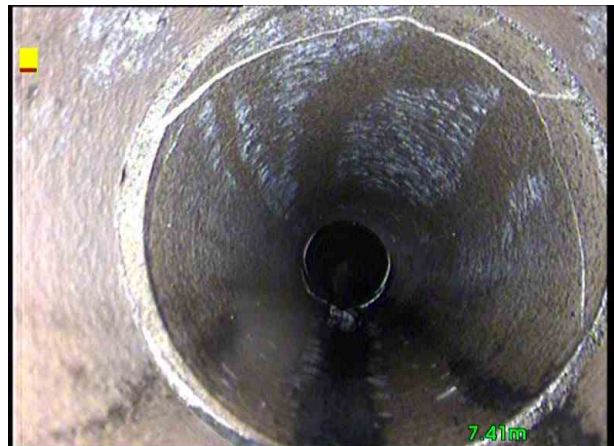
<table><tr> <td style="text-align: right;">0.00</td> <td>WL</td> <td>Water level, 5% of the vertical dimension</td> <td></td> <td></td> <td></td> <td></td> </tr><tr> <td style="text-align: right;">7.41</td> <td>CM</td> <td>Cracks, multiple from 12 o'clock to 12 o'clock</td> <td></td> <td>00:00:42</td> <td>MH2X_1e 8c07a4-11 96-4862-9</td> <td>3 / 2</td> </tr></table>

MH2X_1e8c07a4-1196-4862-93c4-2a00363de73a_20190719_091217_436.jpg, 00:00:42, 7.41 m
 Cracks, multiple from 12 o'clock to 12 o'clock

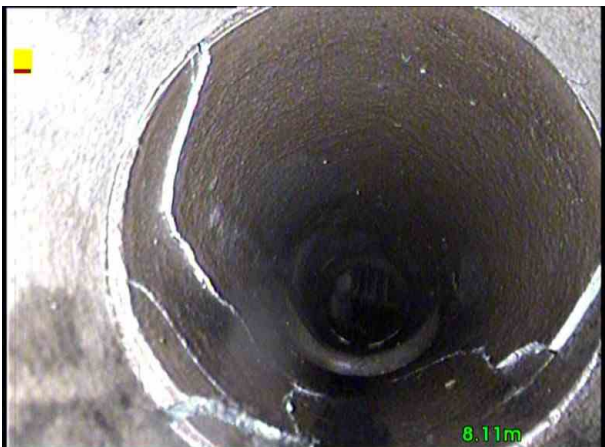
<table><tr> <td style="text-align: right;">0.00</td> <td>WL</td> <td>Water level, 5% of the vertical dimension</td> <td></td> <td></td> <td></td> <td></td> </tr><tr> <td style="text-align: right;">8.11</td> <td>FM</td> <td>Fractures, multiple from 12 o'clock to 12 o'clock</td> <td></td> <td>00:00:46</td> <td>MH2X_0cb 3d7ea-633 a-47b0-97</td> <td>4 / 2</td> </tr></table>

MH2X_0cb3d7ea-633a-47b0-9714-cf7fc0eb537a_20190719_091240_738.jpg, 00:00:46, 8.11 m
 Fractures, multiple from 12 o'clock to 12 o'clock

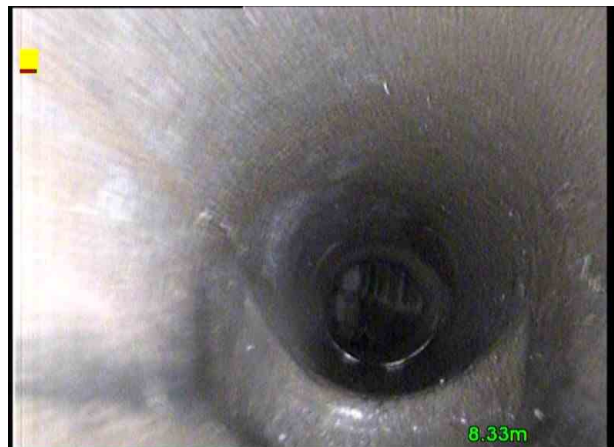
<table><tr> <td style="text-align: right;">0.00</td> <td>WL</td> <td>Water level, 5% of the vertical dimension</td> <td></td> <td></td> <td></td> <td></td> </tr><tr> <td style="text-align: right;">8.42</td> <td>JN</td> <td>Junction at 6 o'clock, diameter: 150mm: BACKDROP</td> <td></td> <td>00:00:51</td> <td>MH2X_9a 43973b-9c d2-4c72-a</td> <td></td> </tr></table>

MH2X_9a43973b-9cd2-4c72-acdc-7cb9bfae800b_20190719_091347_476.jpg, 00:00:51, 8.42 m
 Junction at 6 o'clock, diameter: 150mm, BACKDROP

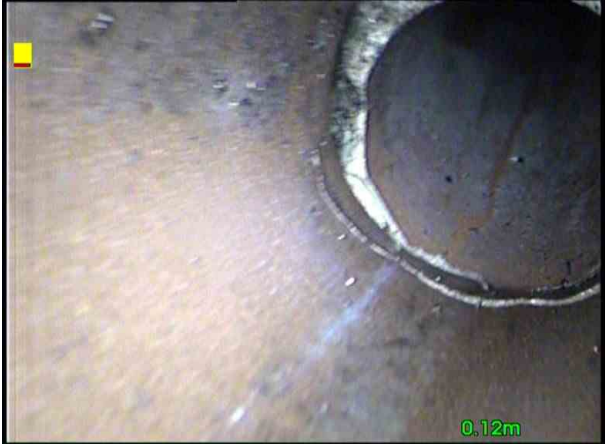
<table><tr> <td style="text-align: center;">0.00</td> <td style="text-align: center;">WL</td> <td>Water level, 5% of the vertical dimension</td> <td></td> <td></td> <td></td> <td></td> </tr><tr> <td style="text-align: center;">0.28</td> <td style="text-align: center;">JDM</td> <td>Joint displaced, medium</td> <td></td> <td style="text-align: center;">00:00:08</td> <td style="text-align: center;">GULLYX_ ea12e868- f5db-475e-</td> <td style="text-align: center;">1 / 3</td> </tr></table>

GULLYX_ea12e868-f5db-475e-aeac-0d1df9fea055_20190719_091651_803.jpg, 00:00:08, 0.28 m
Joint displaced, medium

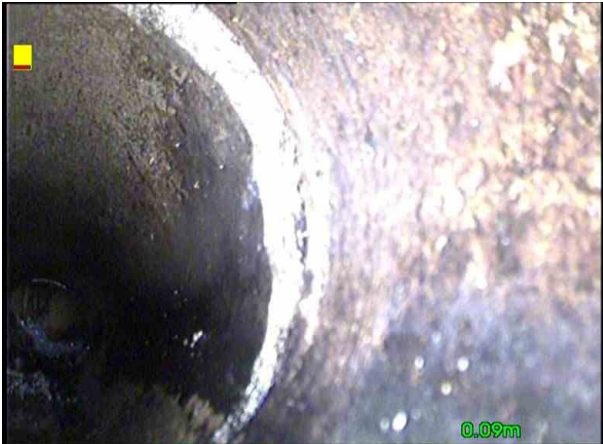
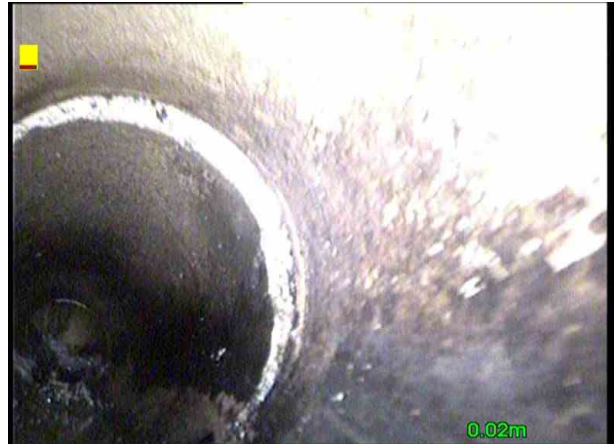
<table><tr> <td style="width: 15%;">0.00</td> <td style="width: 10%;">WL</td> <td style="width: 45%;">Water level, 5% of the vertical dimension</td> <td style="width: 10%;"></td> <td style="width: 10%;"></td> <td style="width: 5%;"></td> </tr><tr> <td style="color: red;">0.09</td> <td style="color: red;">JDM</td> <td style="color: red;">Joint displaced, medium</td> <td style="color: red;">00:00:06</td> <td style="color: red;">WCX_db6 3b882-4ab a-429c-9ff</td> <td style="color: red;">1 / 3</td> </tr></table>

WCX_db63b882-4aba-429c-9ff7-fb83d9a492a5_20190719_091904_894.jpg, 00:00:06, 0.09 m
 Joint displaced, medium

WCX_c514130f-8838-4540-ab91-79de0b5f209d_20190719_091915_100.jpg, 00:00:06, 0.09 m
 Joint displaced, medium

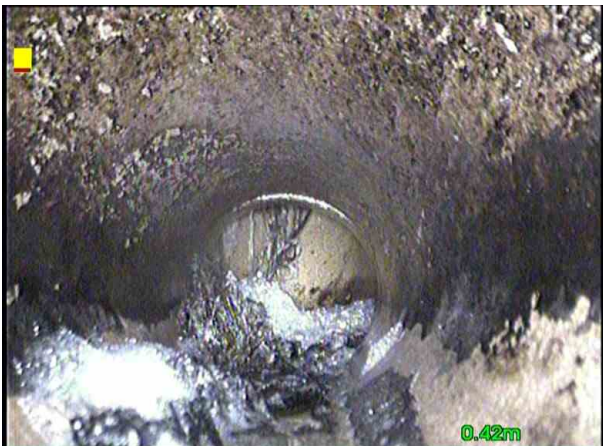
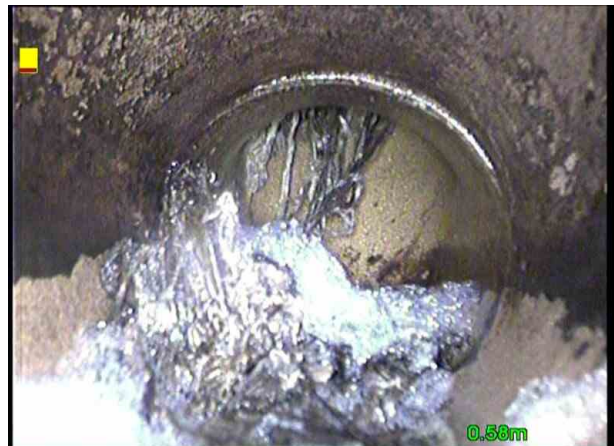
The survey has also shown that horse hair pipe sleeving has been used. The sleeving is intruding the pipework serving the WC resulting in a cross sectional loss of up to 30%. The horse hair should be removed to prevent future blockages.

<table><tr> <td style="width: 15%;">0.00</td> <td style="width: 10%;">WL</td> <td style="width: 45%;">Water level, 5% of the vertical dimension</td> <td style="width: 10%;"></td> <td style="width: 10%;"></td> <td style="width: 5%;"></td> </tr><tr> <td style="color: green;">0.44</td> <td style="color: green;">S01</td> <td style="color: green;">OBJ Other obstacles, other object in invert at joint from 4 o'clock to 9 o'clock, 25% cross-sectional area loss, start: HORSE HAIR PIPE SURROUND</td> <td style="color: green;">00:00:10</td> <td style="color: green;">WCX_103 231f6-ffab- 4e4a-bacb</td> <td></td> </tr></table>

WCX_103231f6-ffab-4e4a-bacb-05face603c94_20190719_092045_737.jpg, 00:00:10, 0.44 m
 Other obstacles, other object in invert at joint from 4 o'clock to

WCX_c872ec96-1e5d-438a-8b45-e22b98e4de62_20190719_092051_635.jpg, 00:00:10, 0.44 m
 Other obstacles, other object in invert at joint from 4 o'clock to

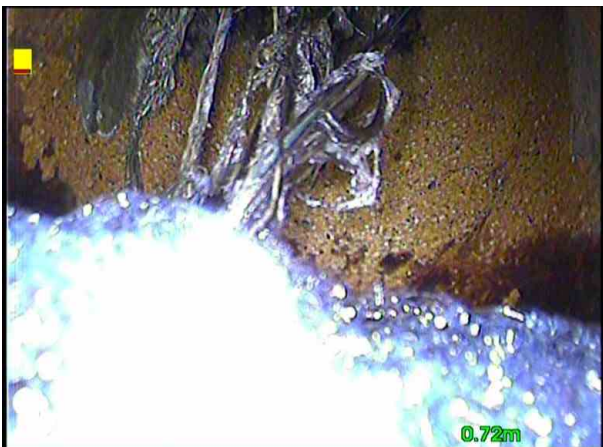
<table><tr> <td style="width: 15%;">0.00</td> <td style="width: 10%;">WL</td> <td style="width: 45%;">Water level, 5% of the vertical dimension</td> <td style="width: 10%;"></td> <td style="width: 10%;"></td> <td style="width: 5%;"></td> </tr><tr> <td style="color: green;">0.73</td> <td style="color: green;">S02</td> <td style="color: green;">OBJ Other obstacles, other object in invert at joint from 12 o'clock to 12 o'clock, 40% cross-sectional area loss, start: HORSE HAIR PIPE SURROUND</td> <td style="color: green;">00:00:15</td> <td style="color: green;">WCX_ea5 1cb9a-adf 6-4fb3-9f3</td> <td></td> </tr></table>

WCX_ea51cb9a-adf6-4fb3-9f3d-a36a19991198_20190719_092201_694.jpg, 00:00:15, 0.73 m
 Other obstacles, other object in invert at joint from 12 o'clock to
